POSTBUCKLING RESPONSE OF GRAPHITE-EPOXY PLATES LOADED IN COMPRESSION

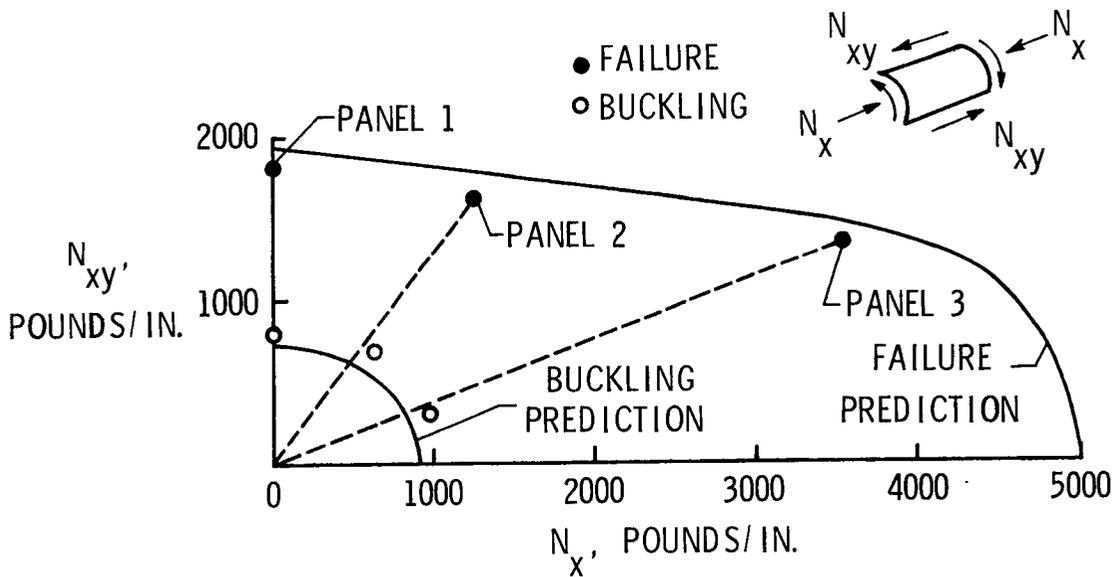
Figure 18

The results of the shear and combined shear and compression tests of the panels described in Figure 17 are shown in Figure 18. Three panels were tested to failure. The first panel was loaded in shear only, the second panel was loaded with approximately equal magnitudes of shear and compression stress resultants and the third panel was loaded with approximately three times as much compression as shear. The predicted buckling and failure interaction curves for shear N_{xy} and compression N_x loading are shown on the figure. The open circles on the figure represent the buckling data from the tests and the filled circles represent failure of the specimens.

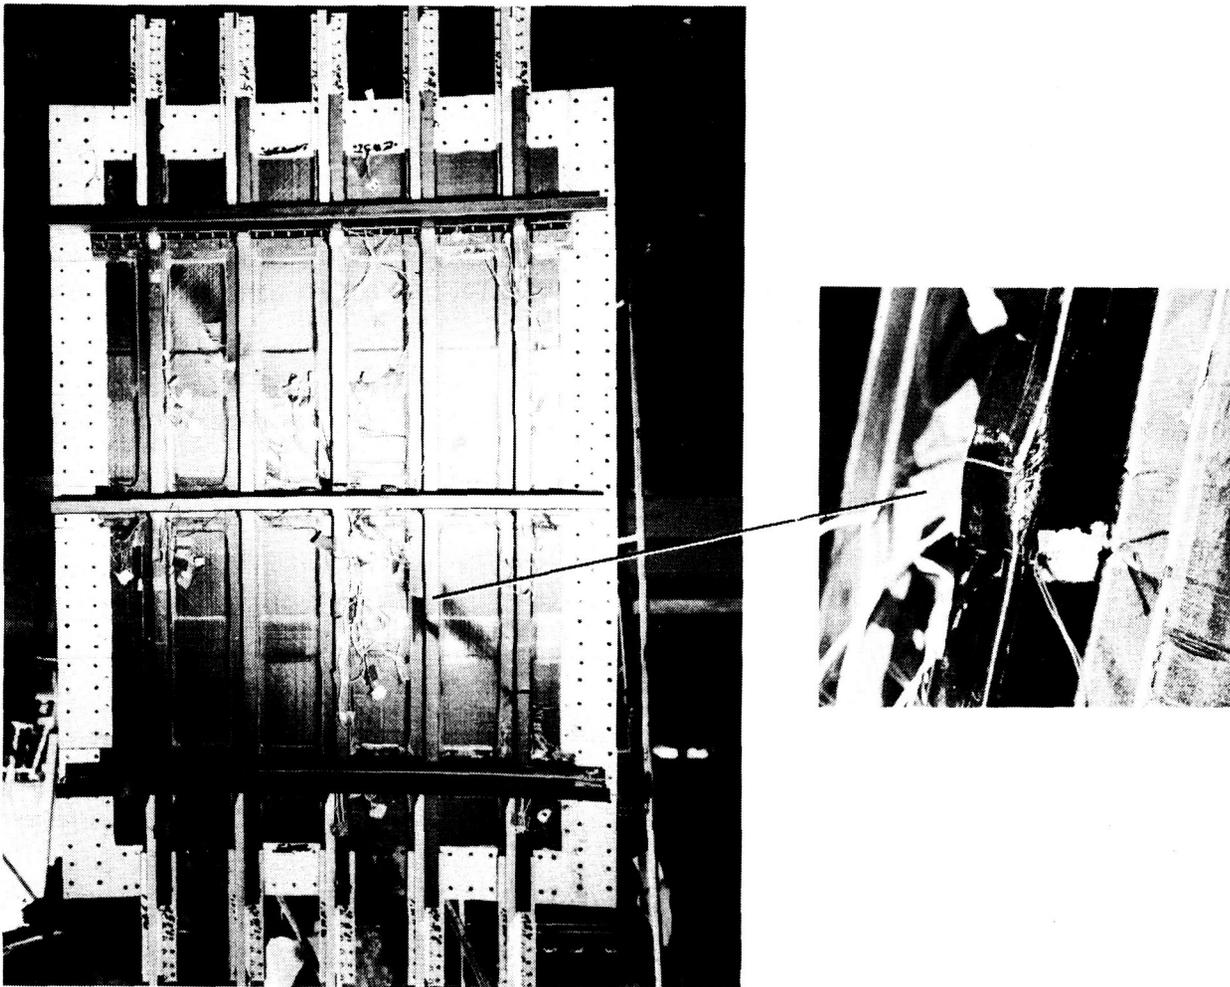
Figure 19

A typical failed specimen that had been loaded in combined shear and compression is shown in Figure 19. The panel failed along a diagonal from frame to frame as shown in the left photograph. The stiffeners appear to have crimped where the diagonal failure intersected the stiffeners as shown in the magnified photograph of the stiffener on the right. No stiffener crippling was observed in the panel that was tested in shear only since no compression load was applied to the stiffeners of this panel. Some frame damage was observed after failure of the panel loaded in shear only; however the frame damage may have been caused by the test fixture.
